NATIONAL PROGRAM FOR INSPECTION OF NON-FEDERAL DAMS
MILL POND DAM MA 0043. (U) CORPS OF ENGINEERS WALTHAM
MA NEW ENGLAND DIV APR 79

MA 00436 April 1979

1. Overview of Mill Pond (Myrtle Street) Dam

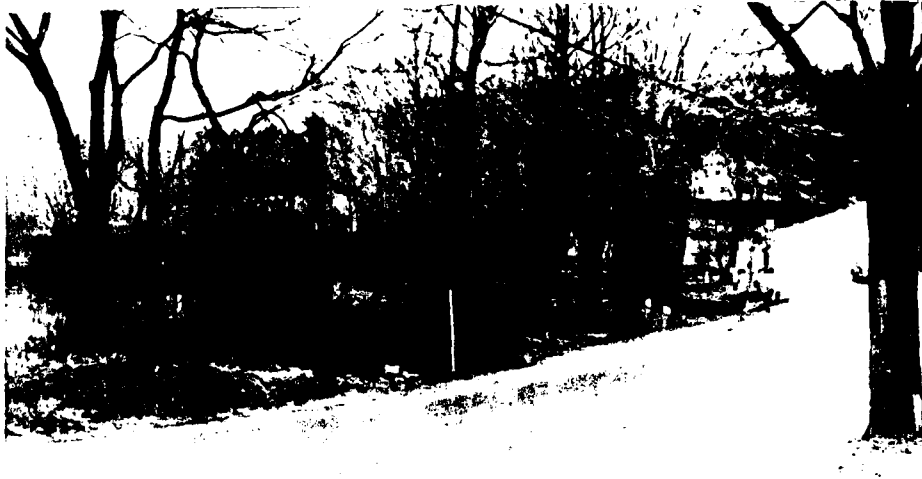
1. The upstream slope, crest and downstream toe are overgrown with brush, saplings and large trees up to 1 ft. in diameter, Photos No. 2 through 7. Tree roots have grown throughout the embankment and are exposed in eroded areas, Photo No. 5.
2. The stone wall on the upstream side has several stones dislodged, resulting in an unprotected shoreline in local areas, Photo No. 2. Soil loss and erosion is evident where the stone slope protection is missing.
3. The sloping top of the embankment is eroded and rutted by runoff and unrestricted foot traffic, Photo No. 3. As can be seen on Photo No. 8, taken when the water level was about 0.3 ft. below the top of dam following a storm in January 1979, the dam was being overtopped to the left of the blocked sluice gate outlet and sandbags were resisting further overtopping

4. Overview of downstream side of earth embankment

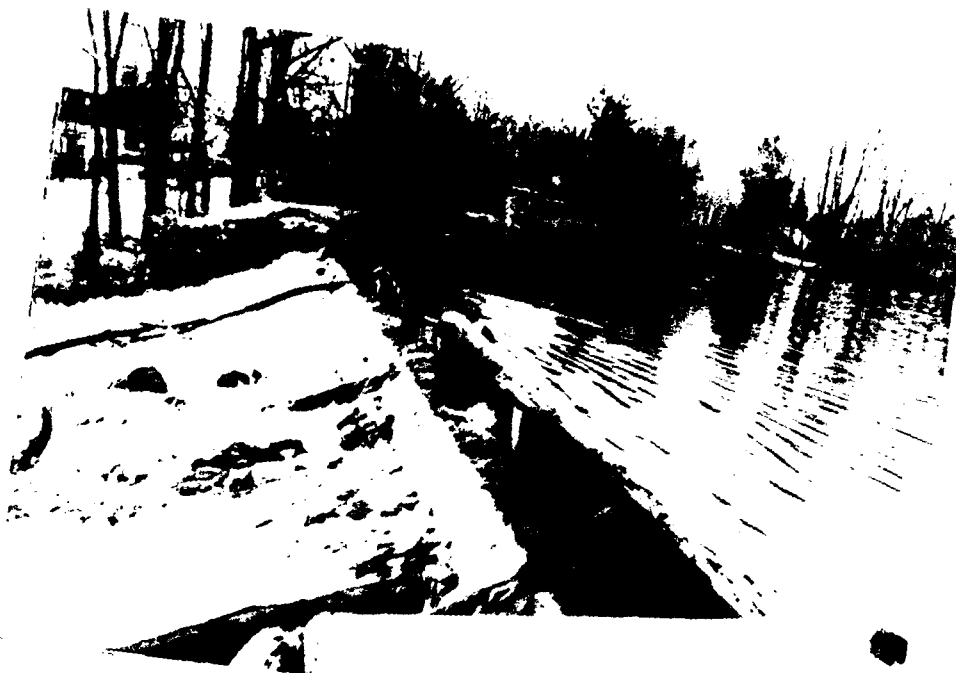
11. Weir and trapped debris at right (southerly)
spillway

3. Repair upstream riprap protection and restore grade to top of dam at the left abutment.
4. Remove the flashboard supports on the spillway weirs, since they only serve to trap debris and further reduce the already grossly inadequate spillway capacity. This would also eliminate the possibility of anyone installing flashboards at the spillways.

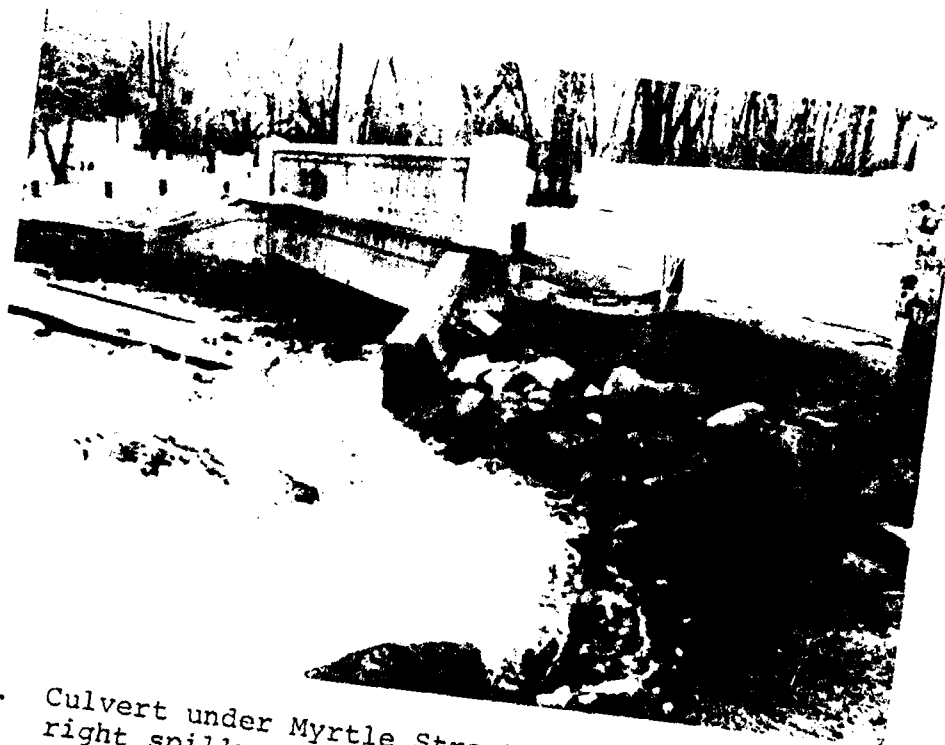
The remains of stone masonry walls can be seen on both sides of the cascades and discharge channels. Except for the left wall of the right spillway discharge channel, Photos No. 12 and 13, those portions of the stone walls which are still intact are in poor condition. Water could be seen flowing from the joints at the bottom of the remains of the right wall at the right spillway cascade, Photo No. 7. The left wall of the left spillway discharge channel is partially washed out, and part of the bank is undercut by about 4 ft., Photo No. 16.

12. Culvert under Myrtle Street downstream of
right spillway

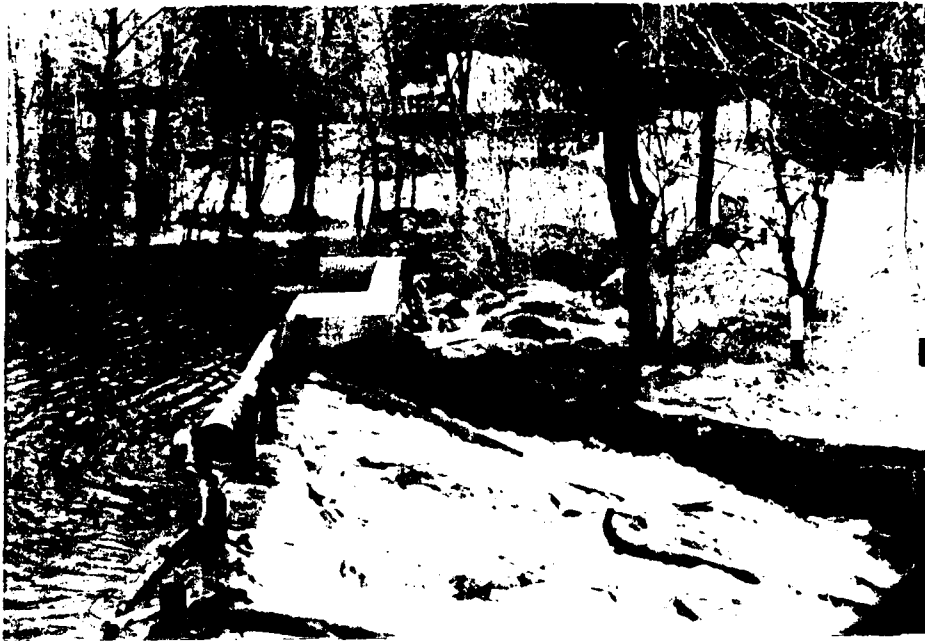
The general condition of the "L" shaped concrete wall, Photos No. 13 and 14, is good with some minor staining observed. The earth backfill on the downstream side has been washed out to about 3 ft. below the top of the wall, apparently most recently by overtopping of the wall in January 1979.

13. Concrete wall separating two spillways

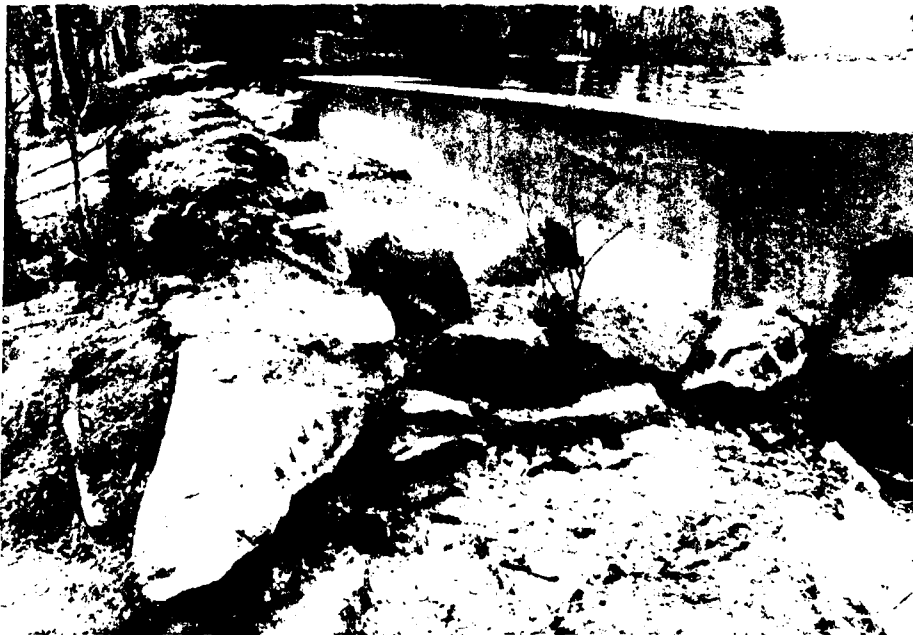
14. Eroded earth berm on downstream side of
concrete wall

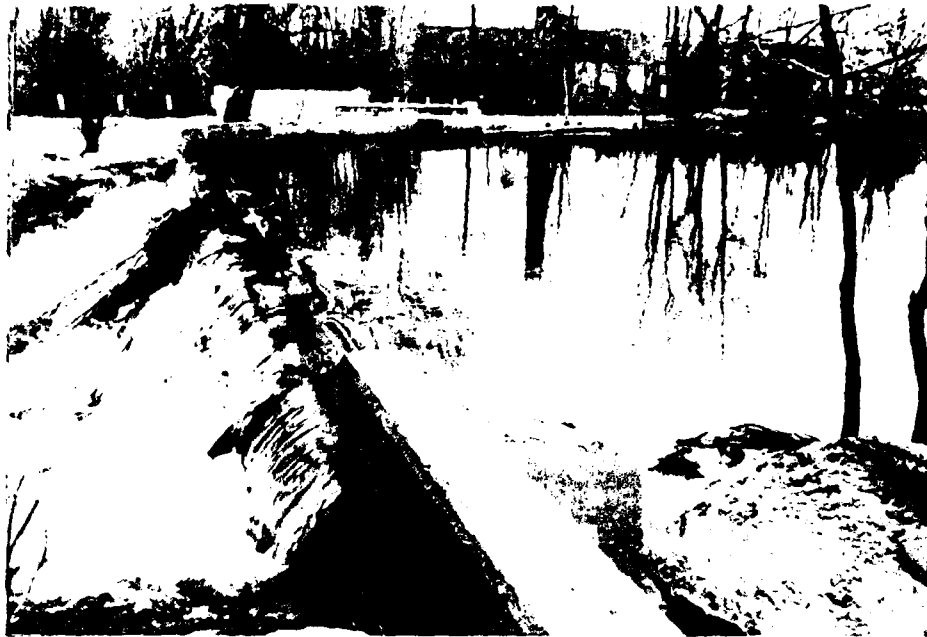
15. Weir and trapped debris at left (northerly)
spillway

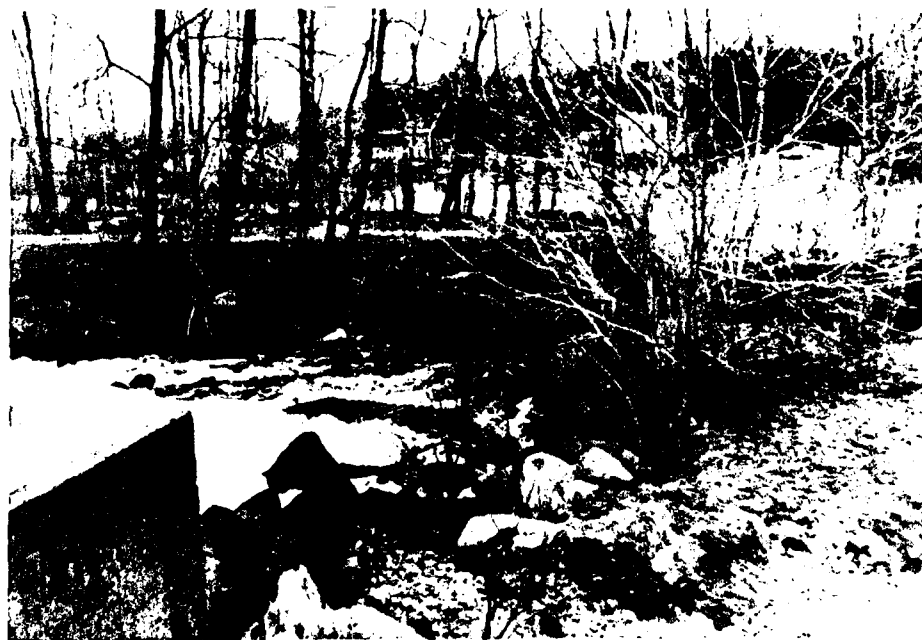
16. Bank undercut along left spillway discharge
channel

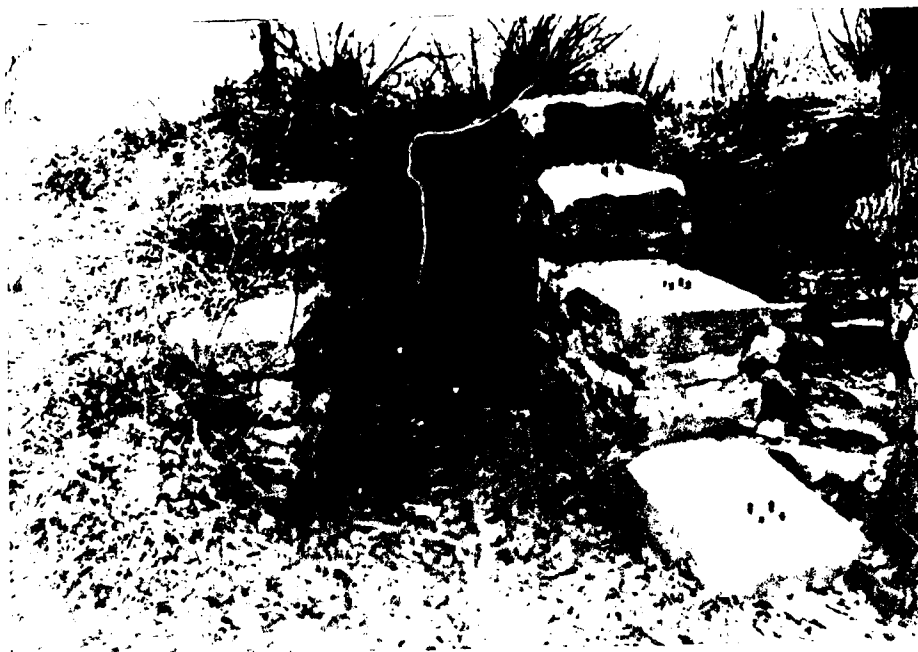
k. Regulating Outlets. There are no regulating outlets presently operational at this dam. There are provisions for flashboards at both spillways, but none were observed during the visual examination. About 25 ft. to the right of the southern spillway is an abandoned sluice gate outlet which is blocked up with concrete.

17. Sluice gate outlet in earth embankment
blocked by concrete

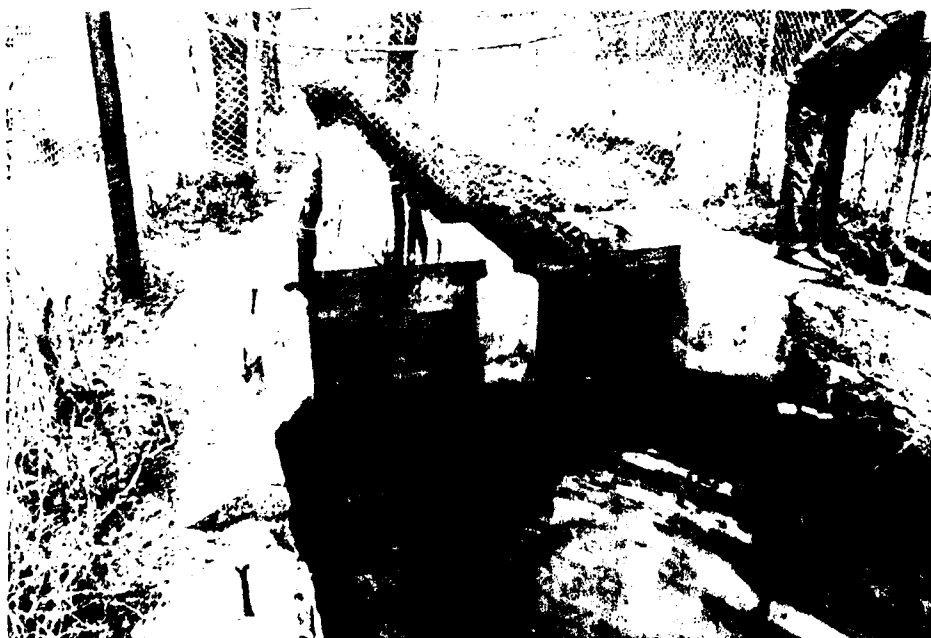
At the right abutment of the dam there is a 9.4 ft. wide by 8 ft. deep entrance channel which feeds through control gates to a water supply outlet channel which tapers from 7.4 ft. wide at the gates to 4.8 ft. wide at Myrtle Street. The walls of the entrance channel and the start of the outlet channel are of stone masonry and in good condition. The remains of a trash rack were observed at the pond end of the entrance channel. Bolts observed along both sides of the entrance channel indicate some type of structure may have been present over the channel at some time in the past. A twin channel concrete gate structure with two 3.2 ft. wide by 8 ft. high steel stop plates in place during the site visit controls flow to the outlet channel. The size of the guides, however, indicates that the original controls were probably wood stoplogs or gates. The condition of the concrete is good, with some minor spalling and staining observed. The entrance end of the water supply outlet channel is shown in Photo No. 20.

18. Steel gates at entrance of air conditioning
water supply outlet channel

5. Replace trash rack at entrance to water supply outlet channel.
6. Provide a more positive seal than the existing gates at the entrance to the water supply outlet channel. Stoplogs could be used as a control weir for this outlet from which Gordon-Mindick Properties draws air conditioning water.

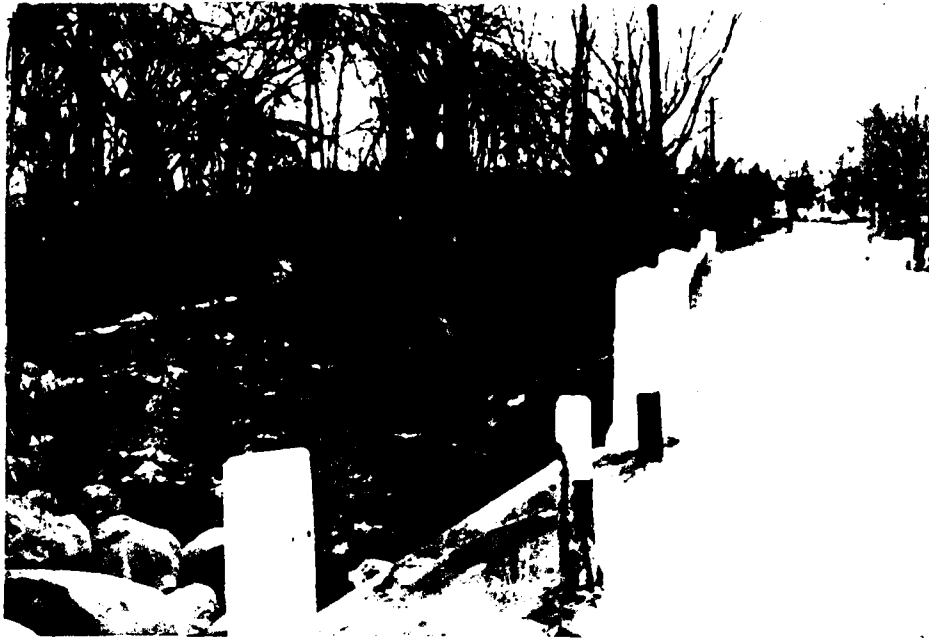
Myrtle Street bridges. The two channels join at a point about 80 ft. downstream of Myrtle Street. Various size trees and boulders were observed on both banks of the river downstream of Myrtle Street, Photo No. 23. The left bank rises at a very steep slope to a height of about 20 ft. The right bank borders the Gordon-Mindick Properties parking area.

23. Downstream channel from left spillway culvert under Myrtle Street

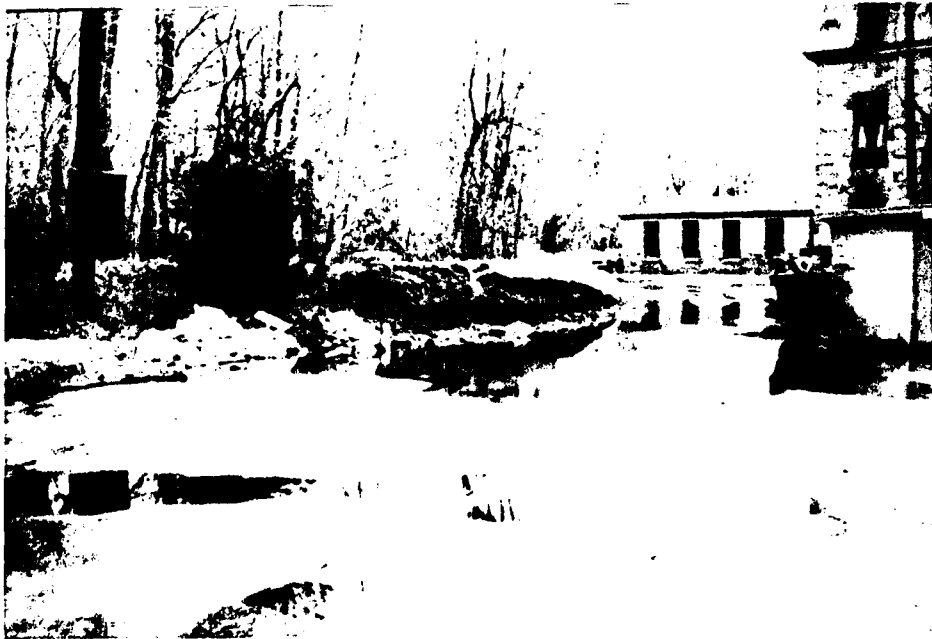
24. Earth flood-control dike along Gordon-Mindick Properties complex (January 1979)
